High Art: Visualising Damage on a Heritage Ceiling

Photographic survey techniques were employed to monitor the condition of the paintwork on the ceiling of the Queen's Staircase at Hampton Court Palace. Illumination was provided by a flash, mounted on an 8 metre telescopic mast, raised to approximately 60 cm below the ceiling, with images were taken from a fixed camera position on the floor of the landing. The photometric stereo method was applied with images from ten lamp positions, to calculate surface normals and a depth map. Cross-sections at the estimated surface resolution of 7.7 pixels/mm, achieved a depth (Z axis) resolution of approximately 100 microns.

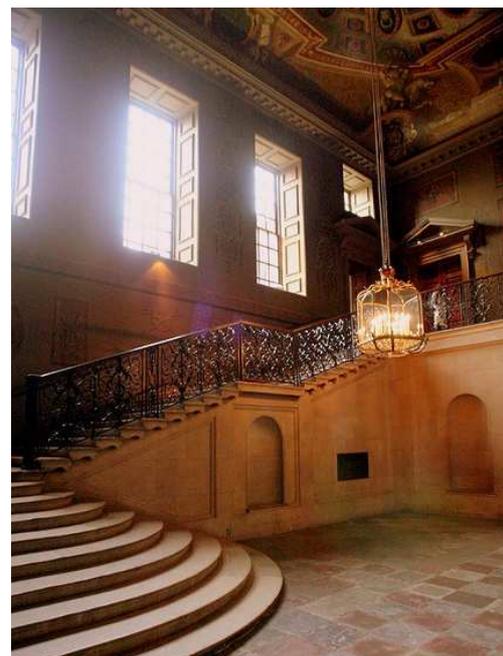
Figure 1: The Queen's Staircase at Hampton Court Palace

The Queen's Staircase is in what is termed the Baroque palace – part of a grand scheme commissioned by George II and Queen Caroline (Allen, 1984). The room is rectangular of dimensions 12m by 21m and has an imposing staircase rising to a landing of 12m by 5.5m. The ceiling height is 12.5m above the ground floor at the centre and 8m above the principal floor landing. Daylight is admitted through three large windows and one smaller high window facing south. A large

chandelier containing a cluster of tungsten lamps hangs low in the centre of the space (Fig. 1).

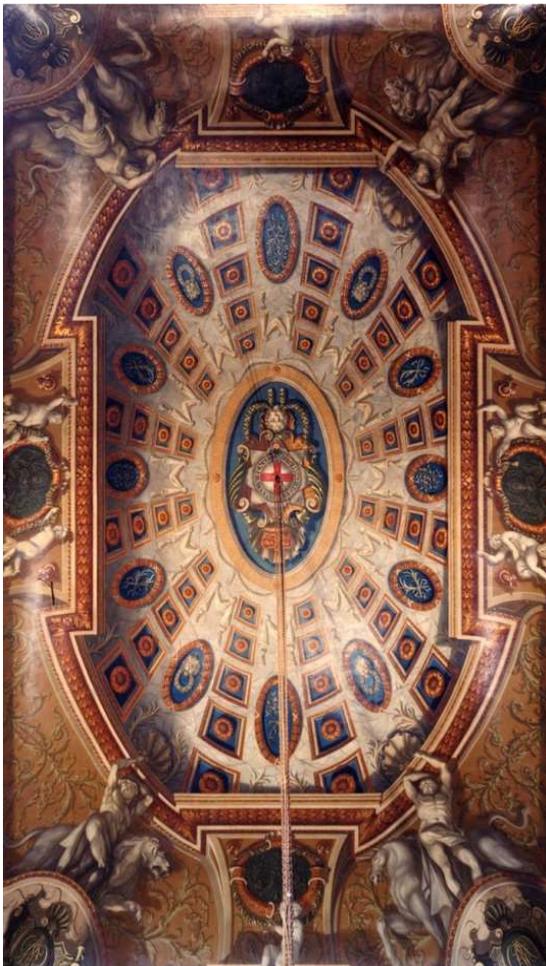
Figure 2: Rectified view of the painted ceiling

The painted ceiling, constructed in lath and plaster, is part of the decorative scheme completed by William Kent in 1734. The painting is executed in oil bound pigment and depicts a marble dome supported by a cornice and figures, featuring a central garter star. Extensive use is made of *trompe l'oeil* techniques with coffered panels, mouldings and elevated height to enhance the grandeur (Fig. 2). The design is centred on a Garter Star and supported by grisaille figures and elaborate ornament. According to Davies (2006): "The ceiling was painted in a consummately skilful and direct style using oil bound pigments and gilding on a lime plaster and riven oak lath support. The artist's preparation for painting comprised a considerable build-up of a red sealant layer together with a triple ground, applied in three separate layers.

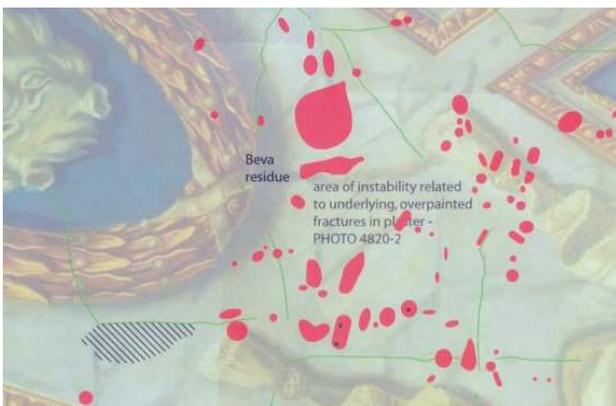
Figure 3: Map of damaged regions from survey, 2010

A detailed survey from a scaffold platform in January 2010 produced rectified photography of the whole ceiling, and mapped the regions of greatest paint loss (Fig. 3). The worst affected areas were found to be in the centre and above the landing. Possible agents of the flaking process were identified as:

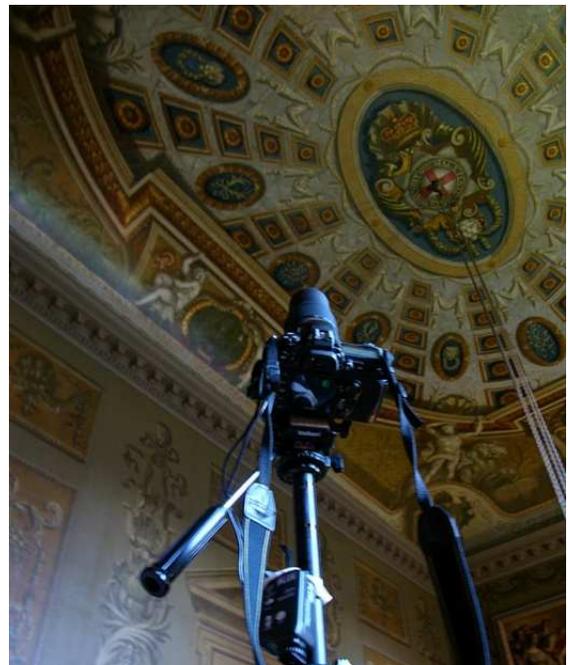
Figure 4: Nikon D200 camera with 300mm telephoto lens and remote flash trigger

Photographic trials were undertaken for the feasibility of capturing suitable images by digital photography from the landing. A previous study by Liang *et al.* (2008) with a camera mounted on a telescope was inconclusive. In this case a Nikon D200 camera with a 55-300 mm zoom lens was mounted on a tripod approximately 2m above the landing floor level, at a distance of 6m below the ceiling (Fig. 4). Images were taken directly from the camera through a USB interface into a laptop PC. The ambient illumination of the ceiling was a combination of the bluish daylight coming through

the windows and the yellowish light from the tungsten bulbs in the chandelier. Additional illumination was provided by a hand-held flash, synchronised to the camera by a radio link. Exposure times ranged from 1 sec to 4 sec at ISO 400 sensitivity, changing the relative contributions to the image of the ambient and flash sources.

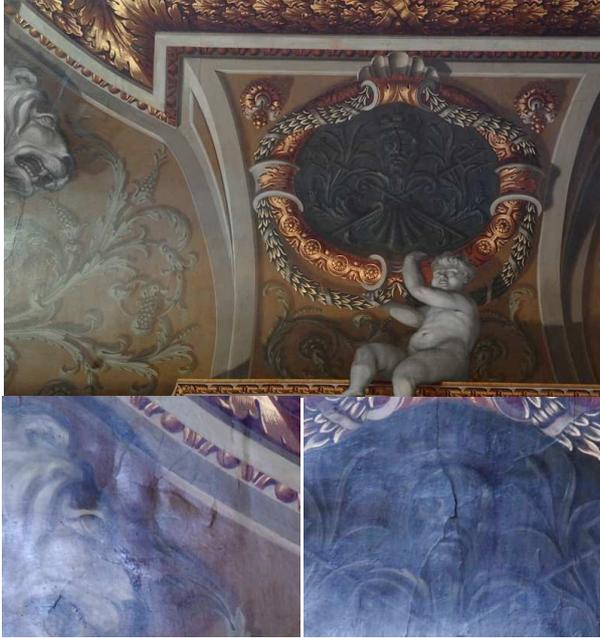
Figure 5: (top) Detail of ceiling in ambient illumination; (bottom) details of paintwork with oblique flash illumination, showing surface deformations and cracks

The ability of oblique flash lighting to show up surface detail was demonstrated in images of the ceiling adjacent to the wall, halfway along the landing (Fig. 5). These were taken with a zoom lens of 55 mm focal length. In ambient light (with no flash) it is difficult to observe any discontinuities in the surface. But when supplemented by side lighting from the flash, details in the images clearly show faults in the surface above the lion's head (top left of image) and in the ghostly face in the shield above the putto (centre right).

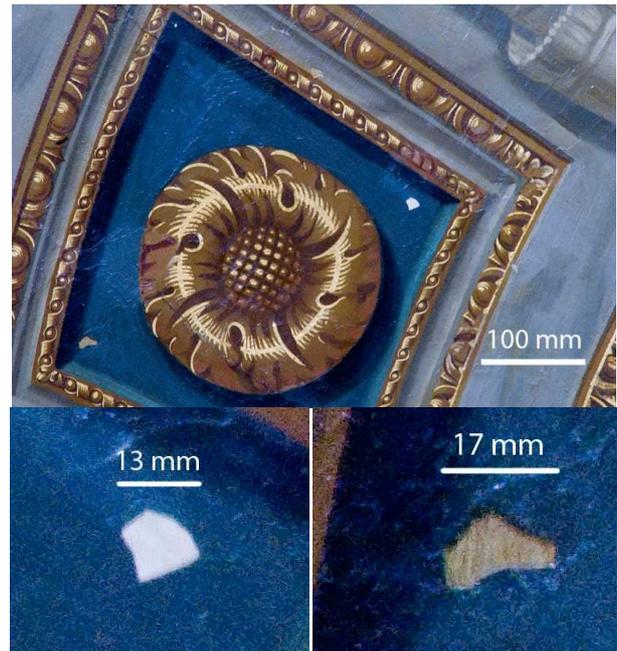
The image of one of the coffer panels (Fig. 6), taken with the 300mm lens, shows two flakes, both of which are easily visible to the unaided eye from the landing level. In the image the widths of these were 118 and 92 pixels, corresponding to flake diameters of 17 and 13 mm respectively. Some error in colour matching (metamerism) is clearly

visible in the retouched paint above the flake on the left, i.e. to the left of the gilded rosette.

Figure 6: (top) Damage to paintwork on coffered panel; (bottom) details of areas where flakes have detached

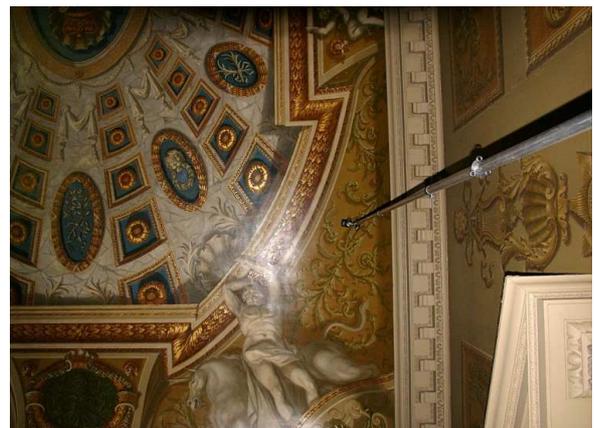
Figure 7: Mast with flash light fully raised in location 1. The target area is the oval garland on the left

Further investigation was undertaken into the effect of raking light on the surface of the ceiling, and whether quantitative information could be derived from images captured by this means. The camera was again mounted on a tripod, at a height of 2.0 metres above the landing floor. The flash light was mounted on an 8m telescopic mast, enabling it to be raised manually to approximately 1 metre below the ceiling (Fig. 7).

The telescopic mast consists of six concentric 18-gauge aluminium tubes, ranging from 2" dia (outermost) to 1" dia (innermost), each of length 1.5 metres, supported by a tripod base. When fully

raised, the top of the mast is 7.75 metres above floor level. The flash unit and radio receiver were both mounted on the top section. The height of the mounted flash above the centre of the pole was 10 cm, hence 7.85 m (= 25'9") above the floor.

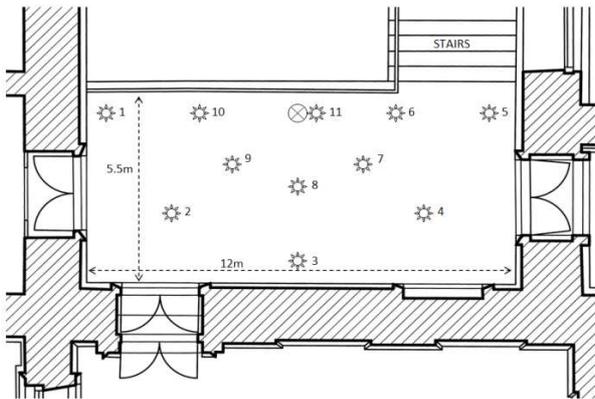
Figure 8: Floor plan of landing of Queen's Staircase, showing locations of camera and flash light

The previous rectified photographic survey of the ceiling in 2010 identified many areas subject to damage. An area in Tile 67 was chosen, depicting two branches of laurel tied by a ribbon within an oval gilded laurel garland. The target area was located on the central longitudinal axis of the ceiling above the centre of the landing rail. The camera was placed directly below, pointing vertically upwards. The flash light when fully raised was at approximately the same level as the top of the cornice. Images were taken from the fixed camera position with the 300mm zoom lens, while the flash light was moved successively to eleven locations around the landing floor (Fig. 8), with five locations in each of two concentric semicircles plus one at the centre (close to the camera axis).

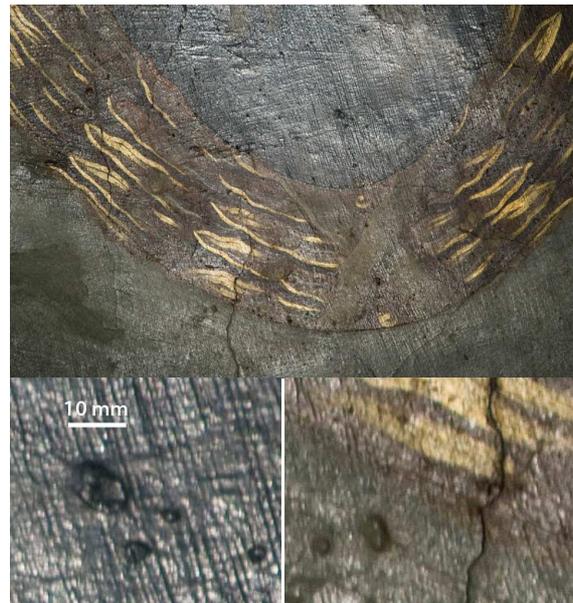
A powerful hand-held torch was used to illuminate the area of interest to assist the autofocus mechanism of the camera to operate correctly. The resulting images were sharp and revealed fine details, at a surface resolution of approx 7 pix/mm. Under the torchlight the images showed strong specular reflections from the glossy surface, with the visual effect of amplifying the contrast of details. Cracks, pits, brushstrokes and construction lines in the paintwork are clearly visible (Fig. 9).

Figure 9: (top) Image of the bottom of garland, illuminated by torchlight; (bottom) details of crack at bottom and bubbling paint in centre, both of size 350x280 pixels corresponding to 50x40 mm

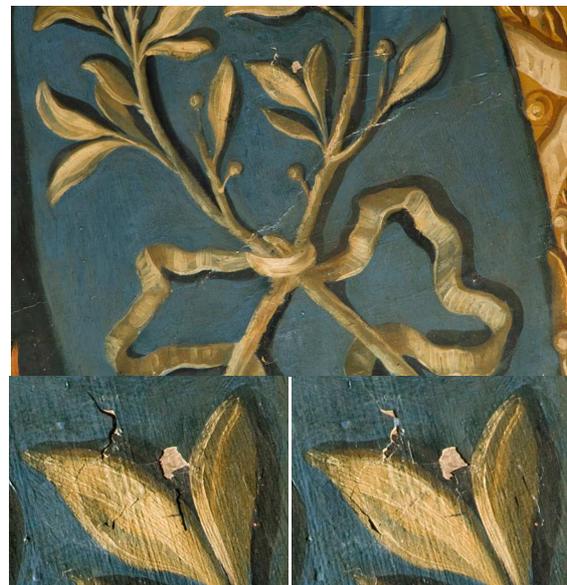
In flash locations 1 and 5 the light was approximately 5.5 metres from the camera axis at a constant distance of 1 metre below the ceiling. The rays from the lamp were therefore incident onto the surface at an angle of $\text{atan}(1/5.5) = 10^\circ$. While not quite 'raking', this angle was low enough to show up surface features clearly, especially comparing images lit from opposite directions (Fig. 10).

Figure 10: (top) Image taken with flash light at location 8, at 1/30 sec, f/11, ISO 250; (bottom) Details of size 700x540 pixels = 100x77 mm taken with flash illumination from locations 1 (left) and 5 (right)

In flash location 8 the light was approximately 2.25 metres from the camera axis and 1 metre below the ceiling. The rays from the lamp were therefore incident onto the surface at an angle of $\text{atan}(1/2.25) = 24^\circ$. This angle provided good illumination over the whole surface while avoiding any specular components and the colour was naturalistic, rendered for flash light at 6150 Kelvin.

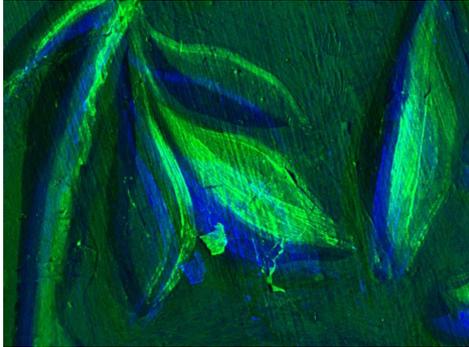
The sequence of 11 images of the oval panel on the ceiling took more than an hour to capture. Although the tripod holding the camera remained in the same position, it took an average of 7 minutes to set up each successive position of the mast holding the flash light. The high magnification of the image through the 300mm lens made the process very sensitive to small perturbations of the camera and its tripod, and resulted in significant misalignment of the images (Fig. 11).

Figure 11: The effect of the misalignment of images is clear in this false-coloured composite of a detail of image 1 (green) and image 5 (blue). The offset is 45 pixels in X and 73 pixels in Y

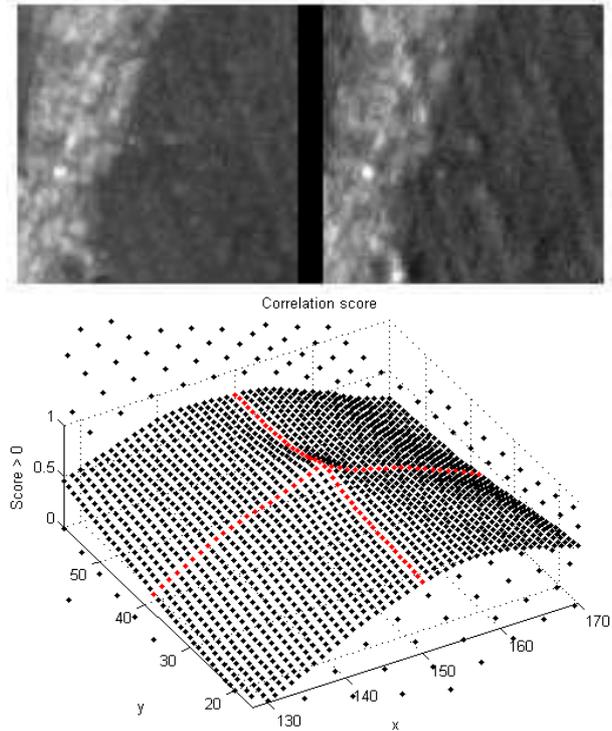
The images were first converted from Nikon raw (nef) format to 16-bit linear (tiff) format files, and the green channel extracted. Thus all registration calculations were performed on 16-bit linear monochrome data. The method for registration used 2D correlation, taking a small square of 101x101 pixels of the reference image, and (in effect) sliding it around an enclosing region of 201x201 pixels from the test image to find the best fit. At each successive pixel coordinate position the correlation coefficient r was calculated (Fig. 12). This method has the advantage of being independent of the brightness and contrast of both images because it takes differences from the respective means and normalises the intensity values.

Figure 12: (top) Corresponding areas of 100x100 pixels from image 7 (left) and image 1 (right). The contrast is greater in the latter because of the lower incident angle of illumination; (bottom) Surface of correlation scores for offsets of ± 21 pixels from the maximum. The red lines indicate the row and column of maximum correlation

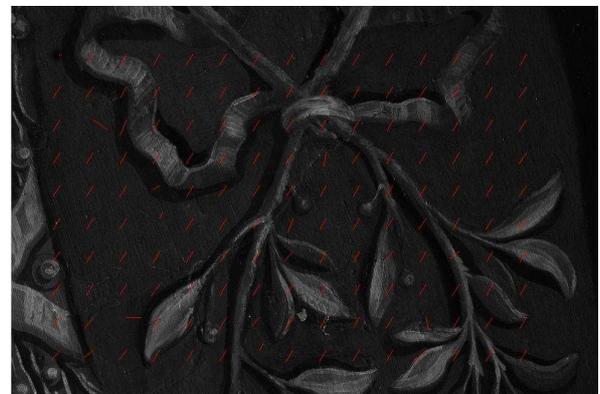
Figure 13: Monochrome of image 1 with translation vectors for image 5, calculated at 150 positions

To speed up computation the correlation procedure was performed in two stages. First a 'coarse' fit was determined by calculating at intervals of four pixels in both X and Y over a 201x201 pixel area, using filtered versions of both images (a 5x5 pixel mean) to reduce the influence of noise. In the second stage the fit was determined for every pixel of the unfiltered images within a local 11x11 pixel area around the maximum position found in the first stage. To make the procedure more robust, the calculation was repeated at 150 locations, on a 15x10 grid with centres separated by 220 pixels in each dimension (Fig. 13).

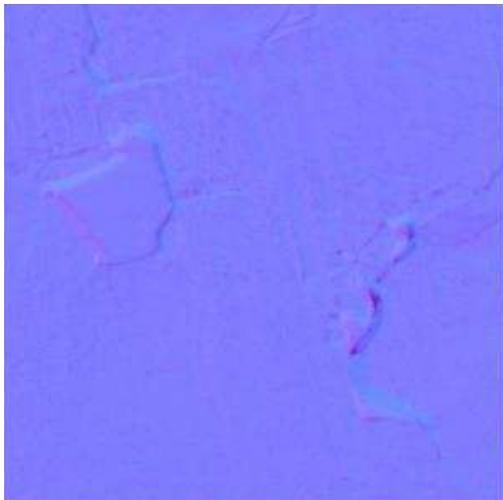
Figure 14: Representation of surface normal, where red channel represents the X normal, green channel the Y normal and blue channel the Z normal

Images from ten lamp positions were used in the calculation. The eleventh image, with the flash adjacent to the camera axis, was not used because the high specular reflectance made it very different in character from the other ten. Although in theory there are ${}^{10}C_3 = 10 \cdot 9 \cdot 8 / 3 \cdot 2 \cdot 1 = 120$ possible combinations of three lamps out of ten, in practice some of these could not be used because two or three of the lamps lie in the same plane. The surface normal for X,Y,Z were calculated for each of the 37 three-lamp combinations for every pixel position. The median of the distribution was taken independently for each of X,Y,Z as an estimate of the true value of the normal. A false-colour image of the normal (Fig. 14) shows that the depth information is rather subtle, but the outlines of the missing flake on the left and the crack on the right are clearly visible.

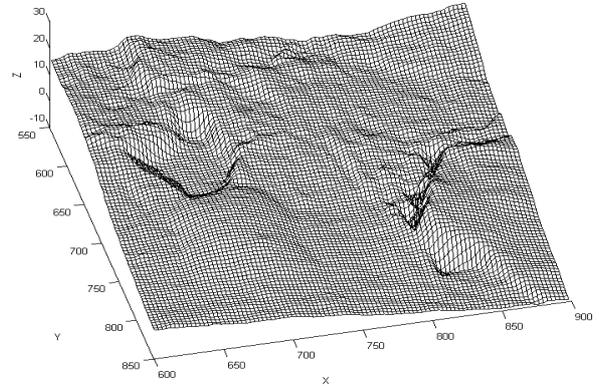
Figure 15: Reconstructed surface of 300x300 pixel area, showing flake (left) and crack (right)

Deriving a depth map from surface normals requires solving the Poisson equation by two-

dimensional integration, and is not at all a trivial procedure. We followed Kovessi's method (2005), in which the surface gradients are projected onto a set of integrable basis functions. This algorithm has the advantage of a simple expression in Matlab and is highly robust to noise.

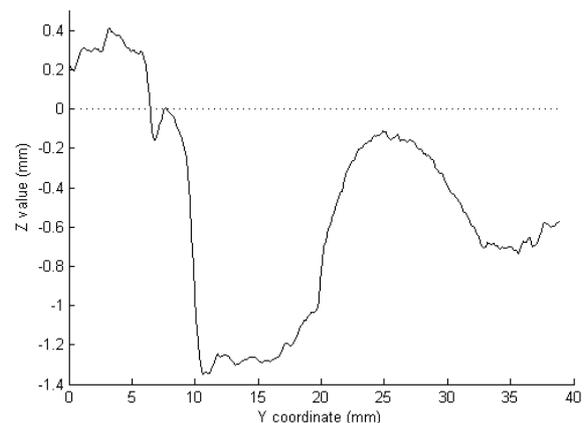
Figure 16: Vertical cross-section through surface profile after correction of normal

After surface reconstruction of the corrected normal values, the cross-sections of Fig. 16 were obtained. The axes in these figures have been converted to physical units of mm, using the estimated surface resolution of 7.7 pixels/mm. Note that the depth (Z axis) resolution achieved by the photometric stereo technique is finer than 0.2 mm (i.e. 200 microns).

The normal were corrected by finding a line of best fit through the normal X data for every row and taking the median of the slope and offset values of all lines within the image region. The value predicted by the regression line across the row was then subtracted from the X normal value, giving the residual for each coordinate position. A similar correction was applied to Y normal down each column. This procedure effectively removed the macro geometry (orientation and curvature of the ceiling relative to the camera) and retained the micro geometry (local cracks, bulges and flakes).

With a better lens (400mm focal length and higher MTF), combined with more careful placement of the flash light in successive positions, a depth resolution of 100 microns could readily be achieved. This is an order of magnitude better than most 3D laser scanners, and compares very favourably with the Z-axis resolution achieved by the best (and most expensive) 3D scanners, operating at a range of 6 metres (Table 1).
